Loss Prevention Report

The Hartford Steam Boiler Inspection and Insurance Company

Insured: Rhode Island Interlocal Risk Management Trust	Client Company: AIG - PEP/IP and TPIP
Location: South Kingstown High School 215 Columbia St Wakefield, RI 02879	Policy No.: 4DU0QYS80
Conferred With: Russell Hill	HSB ID No.: BN-1002532
Service Date: July 20, 2020	HSB Location No.: 71964
	HSB Representative: Bob Voisinet

Inspection Summary

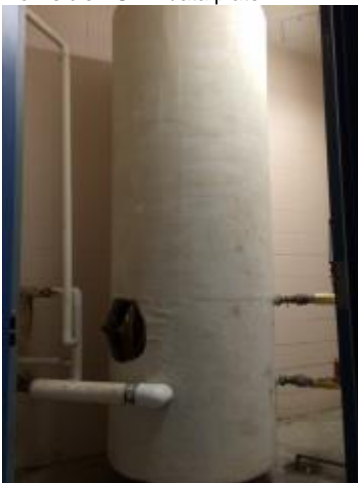
Kitchen hot water supply storage tank located in gas boiler room.

The manufacturers identification label (Stamping) on the hot water storage tank in the gas boiler room is covered with insulation. It cannot be determined if this object was constructed to the requirements of the Jurisdiction. Jurisdictional requirements are that the manufacturers identification label or ASME stamping must be visible.

Status: July 20, 2020 - A discussion with Facilities Director Russell Hill indicated the tank stamping was not identified. He is looking at options of replacing the tank. This recommendation remains open.

Photos
No visible ASME data plate

Locate and make visible the hot water storage tank manufacturers label / ASME stamping.
